**Agnico Eagle Mine – Meadowbank Complex- 2025 ICMC Audit – Corrective Action Plan**

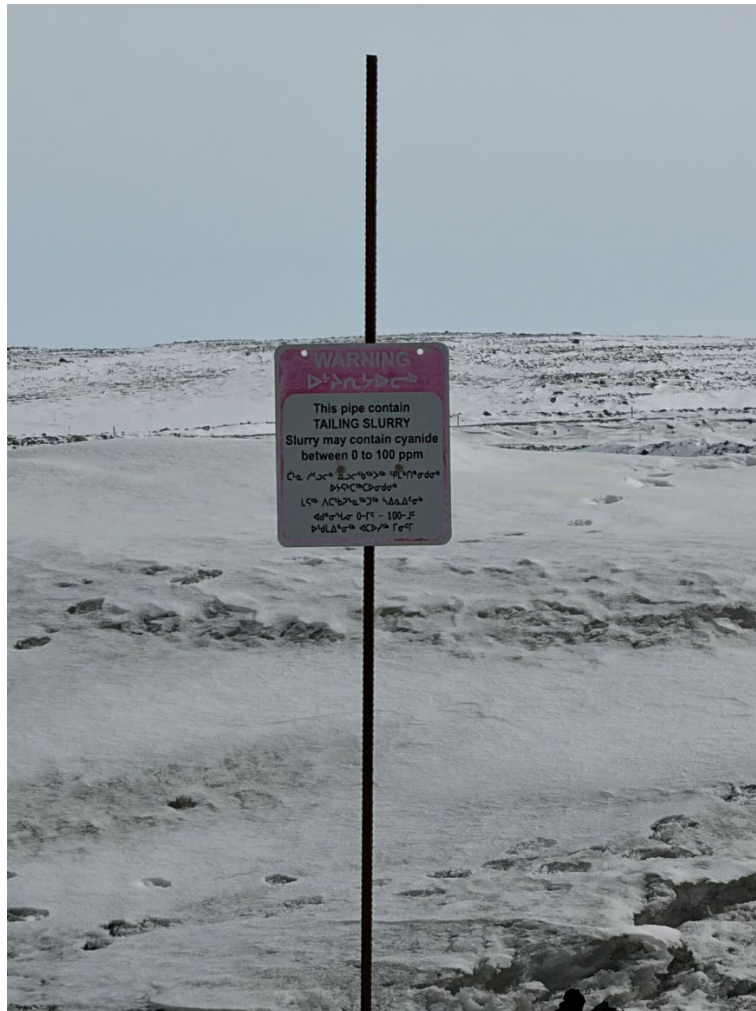
While all areas around the milling facility comply with these standards. Sections of the tailings facility, tailings piping and water reclaim line are missing the required signage. Agnico Eagle will proceed with the installation of additional tailings warning signs, identical to the photo below (see figure 1) along the sections of the active tailings line where warning signs are missing. In addition, installation of similar signs will occur along the water reclaim lines from the Tailings Storage Facility to the Milling Facility. The addition of arrows indicating the direction of flow within the piping. Signs and arrows will be placed every 50ft along the line.

Figure 1: Intended signage along the active tailing's lines

The addition of warning signage at the entrances to the Tailings Storage Facility to meet the requirements of Standard of Practice 6.2.5 will also be completed.

Agnico Eagle is committed to correcting both deficiencies by **September 30<sup>th</sup>, 2026**.
