**SUPPLY CHAIN AUDIT SUMMARY
POLYMETAL INTERNATIONAL PLC
VORO SUPPLY CHAIN - TNT**

MAY 2019

SUMMARY AUDIT REPORT

Audit Company: Wardell Armstrong International (WAI Ltd)

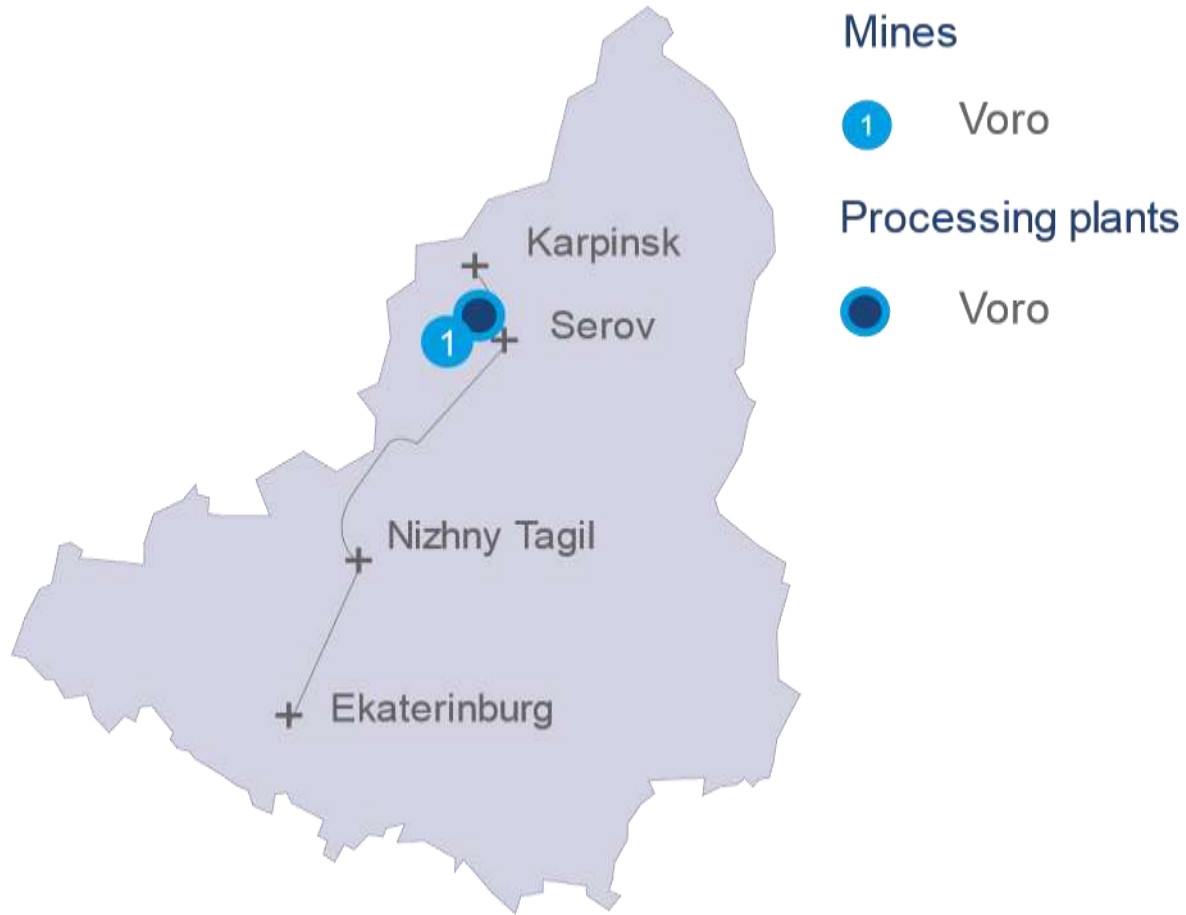
Figure 1:2 Supply Chain

Polymetal (St Petersburg Office) purchases the sodium cyanide for all its mining operations including Voro. Polymetal have signed a 5 year contract with Tongsoh Petrochemical Corp, South Korea (Tongsoh) and Hyosong Corporation, South Korea (Hyosong). Both Tongsoh and Hyosong are signatories of the Code and have full compliance status.

The cyanide for Voro mine enters Russian via the port of St Petersburg.

The cyanide is off loaded in St. Petersburg Port, by the Stevedores and taken to the Dangerous Goods (DG) storage area within the port boundary to await customs clearance before being loaded on to Russian Rail (RZD) station on flat-bed rolling stock to Nizhny Tagil.

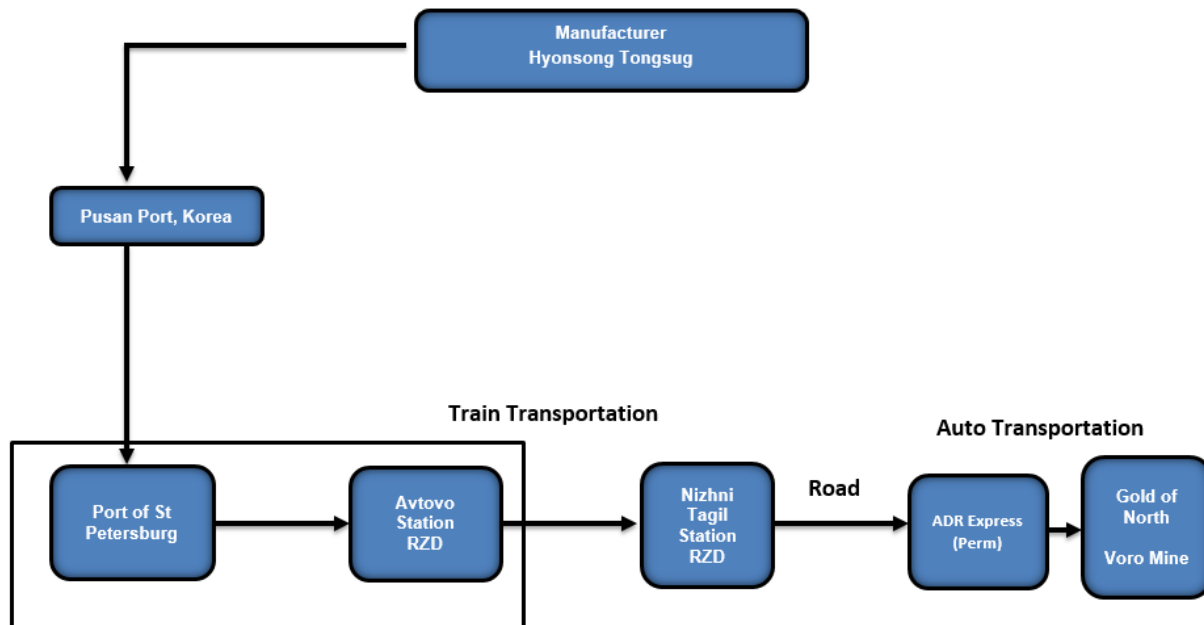
SUMMARY AUDIT REPORT
Figure 1:3 Supply Chain Flow Chart

Polymetal employs TNT (office located in Nizhny Tagil) and ADR Express (office/depot located in Perm) to organize the transportation of cyanide to Voro. TNT prepare all the importation documentation and customs requirements. They also act as the liaison between RZD, ADR and Voro. TNT do not have any vehicles themselves. The Supply Chain audit included verification of St. Petersburg port for the handling (loading and unloading of cyanide from ship to rail cars (flat bed for containers). Rail transport to Nizhny Tagil, transfer to ADR vehicles for onward and final journey to Voro. See Figure 1:3 below.

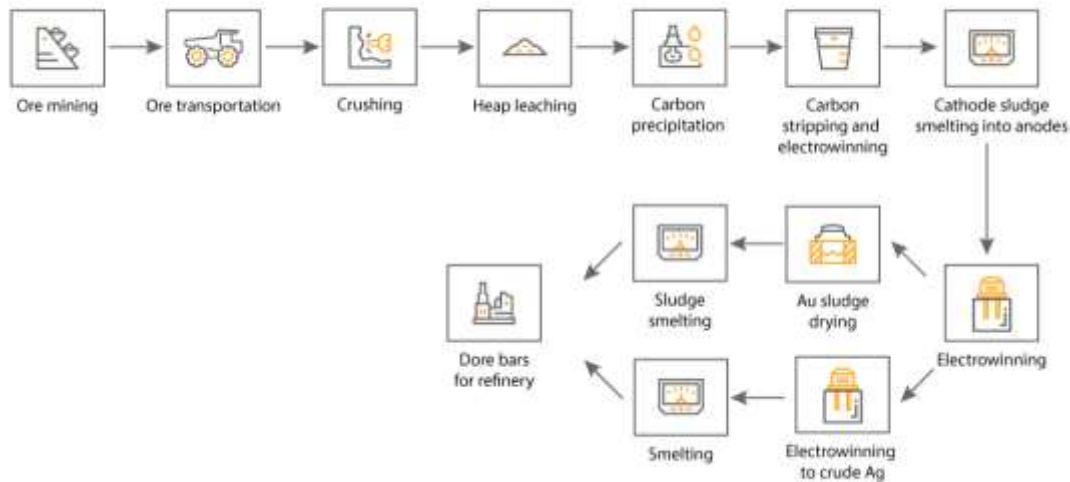
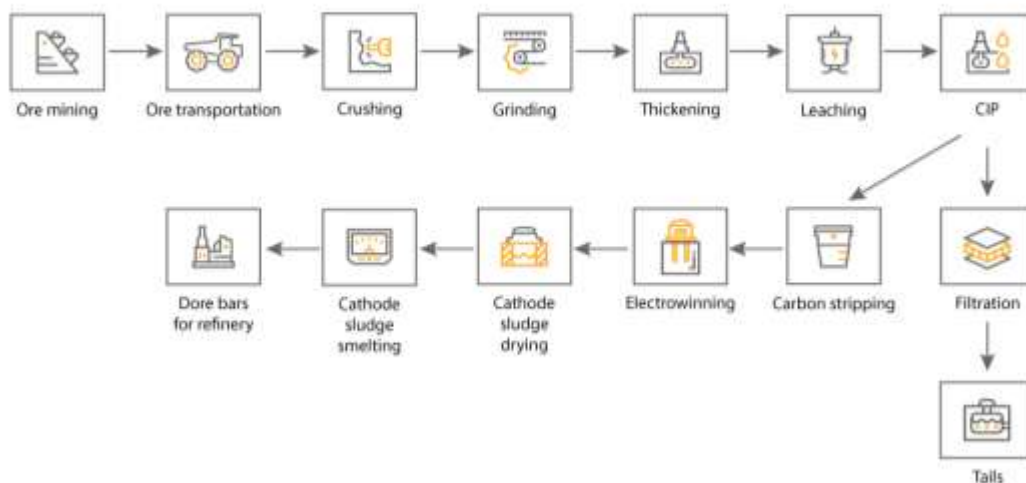
Figure 1:4 Schematic Process Flow Sheets for the Primary Ore and Oxidised Ores

The process plant is fully automated; Figures 1:4 below are the flow sheets for the primary ore and oxidised ores.

The process plant operates as per the illustrative flow sheet (Figure 1.4). Tailings produced from the gold recovery process are sent to the filtration system, where the filtrate is collected and re-circulated in the process (closed loop system). The filter cake dry tailings are deposited in the Tailings Storage Facility (TSF). The TSF is geosynthetically lined with a 1.5mm HDPE geomembrane. Surface water runoff from the tailings is captured and flows to the "surface water runoff pond", and flows to the water treatment plant before being discharged.

The oxidised ore uses a heap leach system, where by cyanide solution is drip fed onto the ore rock in order to liberate the gold into solution. This is collected via numerous collection pipes and drains into collection ponds from where it enters into the process plant for gold recovery. All residue solution is collected within the plant and re-used in the cyanide circuit (closed loop). The cyanide is received in St Petersburg port from South Korea. St Petersburg port holds a license for the importation of Dangerous Goods (DGs), which includes cyanide.

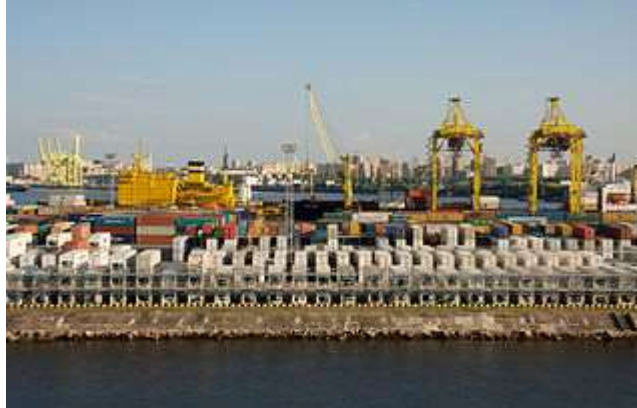
Container Terminal, St. Petersburg Port

The Port of St. Petersburg's container facility covers an area of 89 hectares. The Port is equipped with eight 50-ton STS Panamax cranes, one 104-ton mobile crane, three 45-ton RMG cranes, 19 50-ton rubber-tyred gantry cranes, 37 straddle carriers, and a fleet of reachstackers, terminal tractors, and empty-handlers. The operation of the cranes and equipment is specialised and would require licenses from the Russian Federation Authorities. Having undertaken qualification checks at other ports and railway terminals using cranes, the Auditor has no doubt that the crane operators are qualified, experienced and trained accordingly.

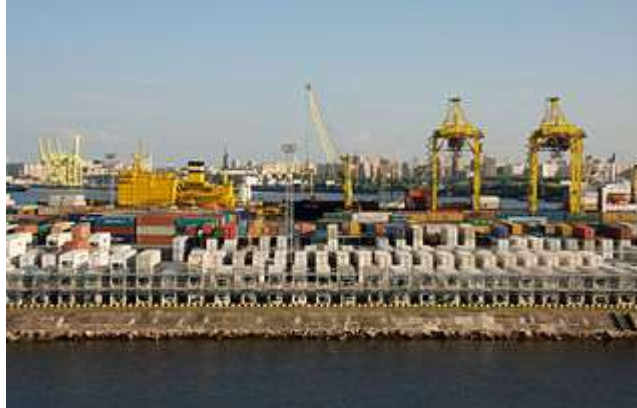
Container Terminal, St. Petersburg Port

The Port of St. Petersburg's container facility covers an area of 89 hectares. The Port is equipped with eight 50-ton STS Panamax cranes, one 104-ton mobile crane, three 45-ton RMG cranes, 19 50-ton rubber-tyred gantry cranes, 37 straddle carriers, and a fleet of reachstackers, terminal tractors, and empty-handlers. The operation of the cranes and equipment is specialised and would require licenses from the Russian Federation Authorities. Having undertaken qualification checks at other ports and railway terminals using cranes, the Auditor has no doubt that the crane operators are qualified, experienced and trained accordingly.

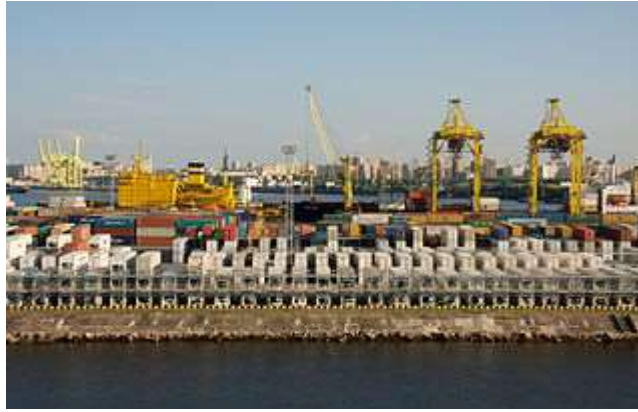
Container Terminal, St. Petersburg Port

The Port of St. Petersburg's container facility covers an area of 89 hectares. The Port is equipped with eight 50-ton STS Panamax cranes, one 104-ton mobile crane, three 45-ton RMG cranes, 19 50-ton rubber-tyred gantry cranes, 37 straddle carriers, and a fleet of reachstackers, terminal tractors, and empty-handlers. The operation of the cranes and equipment is specialised and would require licenses from the Russian Federation Authorities. Having undertaken qualification checks at other ports and railway terminals using cranes, the Auditor has no doubt that the crane operators are qualified, experienced and trained accordingly.
