N.V. VSH TRANSPORT

MOENGO PORT

SUMMARY AUDIT REPORT

This document represents a Summary Audit Report for the Cyanide Code recertification audit of N.V. VSH Transport, a company which conducts stevedoring operations at the Moengo Port owned by N.V. Traymore.

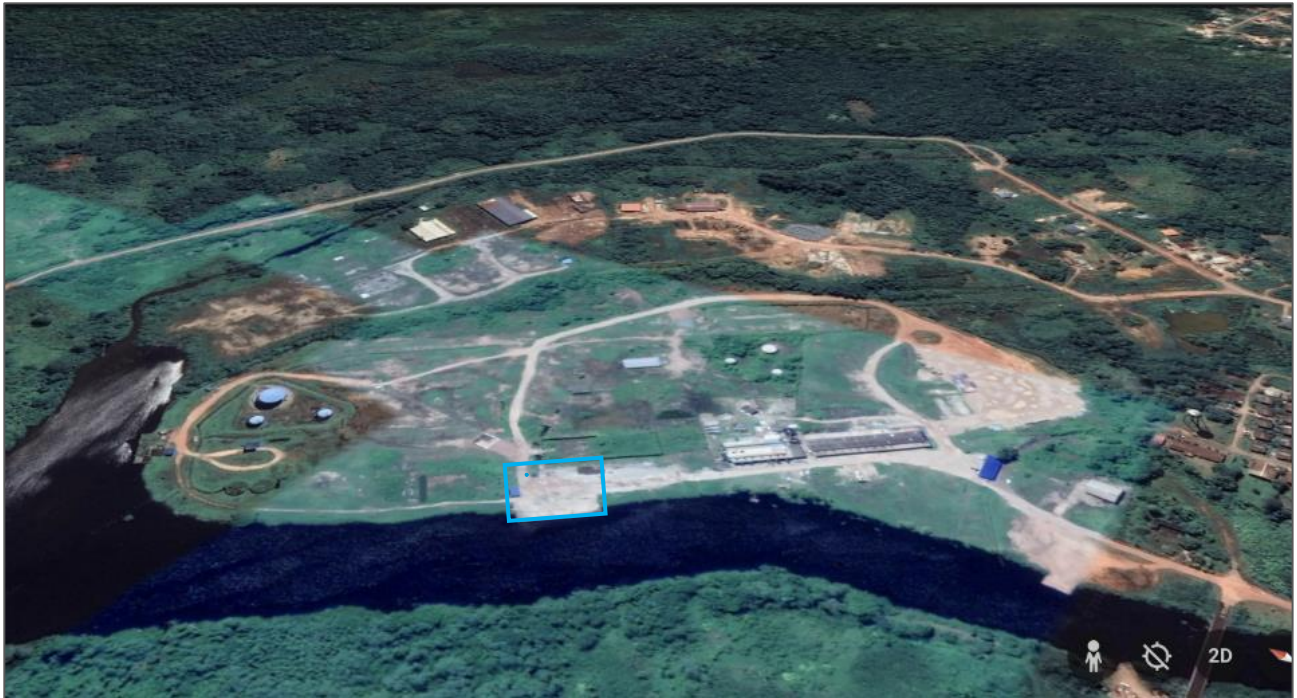
Figure B: Moengo Port Layout (General Dock Highlighted Light Blue)

The port is completely fenced, and has 24/7 surveillance cameras, security guards, parking area, loading and unloading of equipment and bunkering services. The Port has 2 docks to accommodate vessels up to 130m long, Cyanide ISOtainers are offloaded on the General Dock (Figure B).

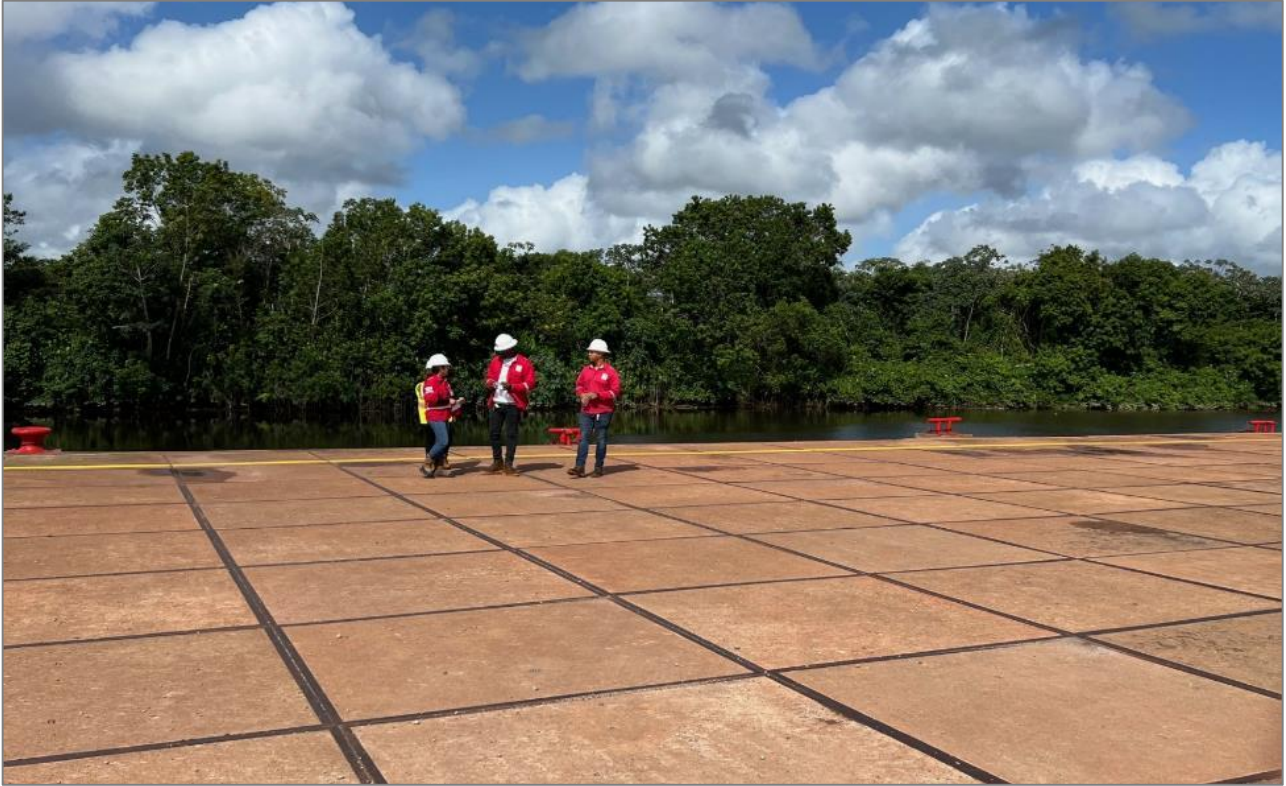
Figure C: Moengo General Dock, 2024

The docking areas have concrete slabs which are well maintained (Figure C). There are no portside cranes at Moengo, therefore ships cranes are used. The stevedoring equipment is either brought to site by VSH or Moengo equipment is used.

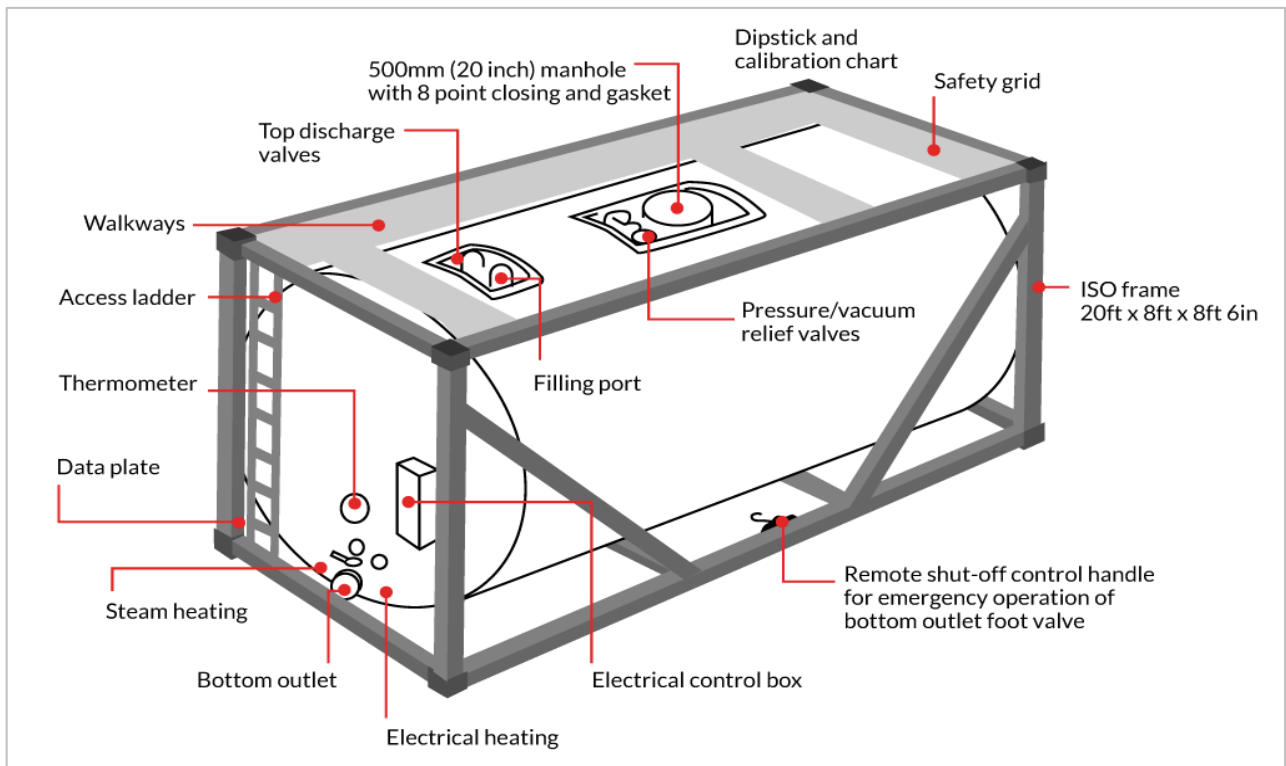
Figure D: Sodium Cyanide Tank with Components Detail

Machinery and equipment that is intended for the use during the cyanide handling at Moengo is similar to one used at the Paramaribo terminal and includes cranes. The Plan provides a description of these items as does of the ISOTainers (Figure D below).

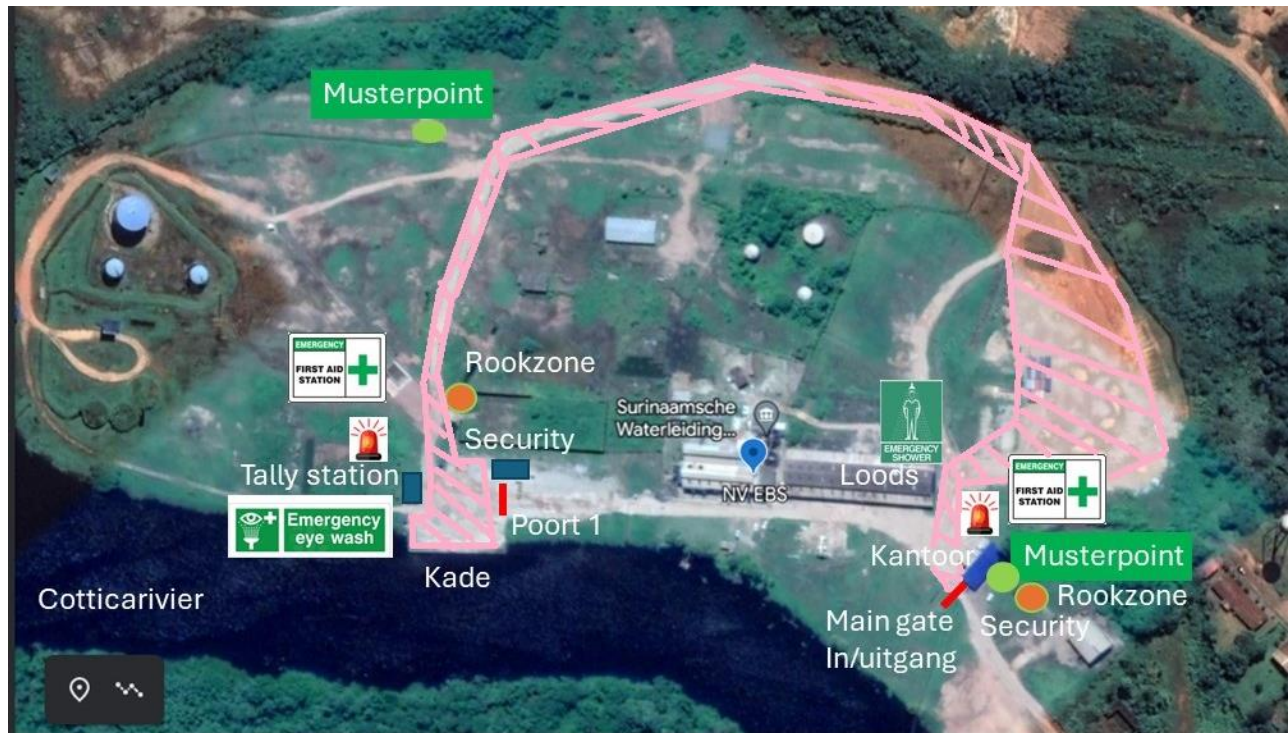
Figure E: Moengo Port Safety Facilities and Areas for Sodium Cyanide Transportation and Handling (Pink)

The Plan considers the port infrastructure and provides the evacuation plan for the relevant facilities. The Plan provides description of first aid points and eye wash locations, with the safety and security facilities and cyanide transport route clearly identified (Figure E below).
