ICMI Certification Summary Audit Report

San Andres Mine San Andres, Honduras

Version 1.3
12 May 2014

AMEC Project: VE52019.200

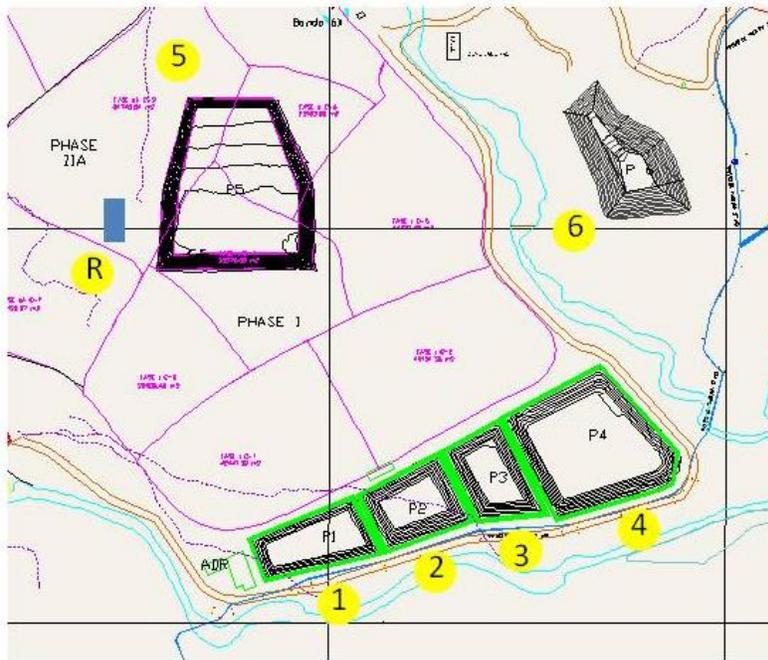
Figure 2: Location of the Storage and Water Treatment Ponds

Figure 2 shows the location of the storage and water treatment ponds at San Andres.

IDENTIFICACION DE PILAS DE SOLUCION Y CIRCUITO DE AGUA INDUSTRIAL

Las pilas 1 y 2, son empleadas para el manejo de solución rica (cargada con oro que viene de las canchas de lixiviación), y el manejo de solución pobre para reenvío a las canchas de lixiviación, respectivamente.

The leach areas use moveable sprayers on the ore piles to apply a solution of 400 parts per million sodium cyanide at a rate of 13 L/m²/hr and a pH >10.3. The pregnant leach solution reports to Pond 1, adjacent to the carbon absorption-desorption-recovery facility (ADR Plant).

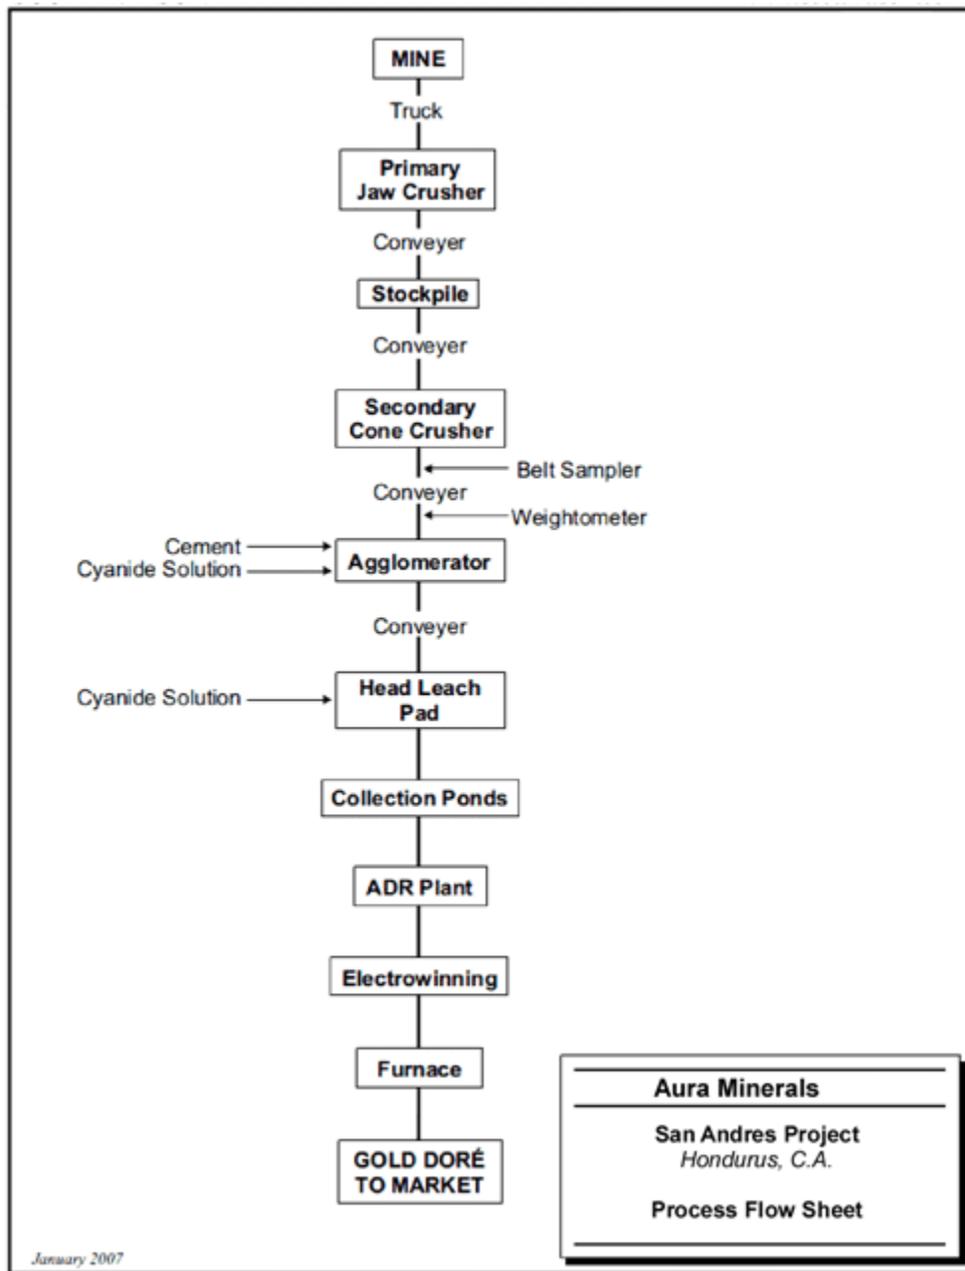
Figure 3: Overview of the Existing Processing Operations at San Andres

A simplified block diagram of the processing operations is shown in **Figure 3**.

The crushing circuit consists of a primary jaw crusher and secondary cone crushers, which reduces the ore size to a nominal 80% passing three inches for leaching. The ore is friable so a significant amount of fines is produced during the crushing stage. These fines are agglomerated using a combination of cement and lime. The crushed and agglomerated product is transferred to a series of conveyors to distribute the material on to the leach pads in 6 metre lifts for leaching.

During the first quarter of 2012, further steps were taken to improve production at San Andres including replacing the primary crusher wobbler with a vibrating grizzly screen ahead of the jaw crusher to improve plant operating time, throughput and efficiency.
