# SOLIDCORE RESOURCES PLC VARVARA MINE

## MINING OPERATIONS SUMMARY AUDIT REPORT

# VARVARA MINING OPERATIONS SUMMARY AUDIT REPORT

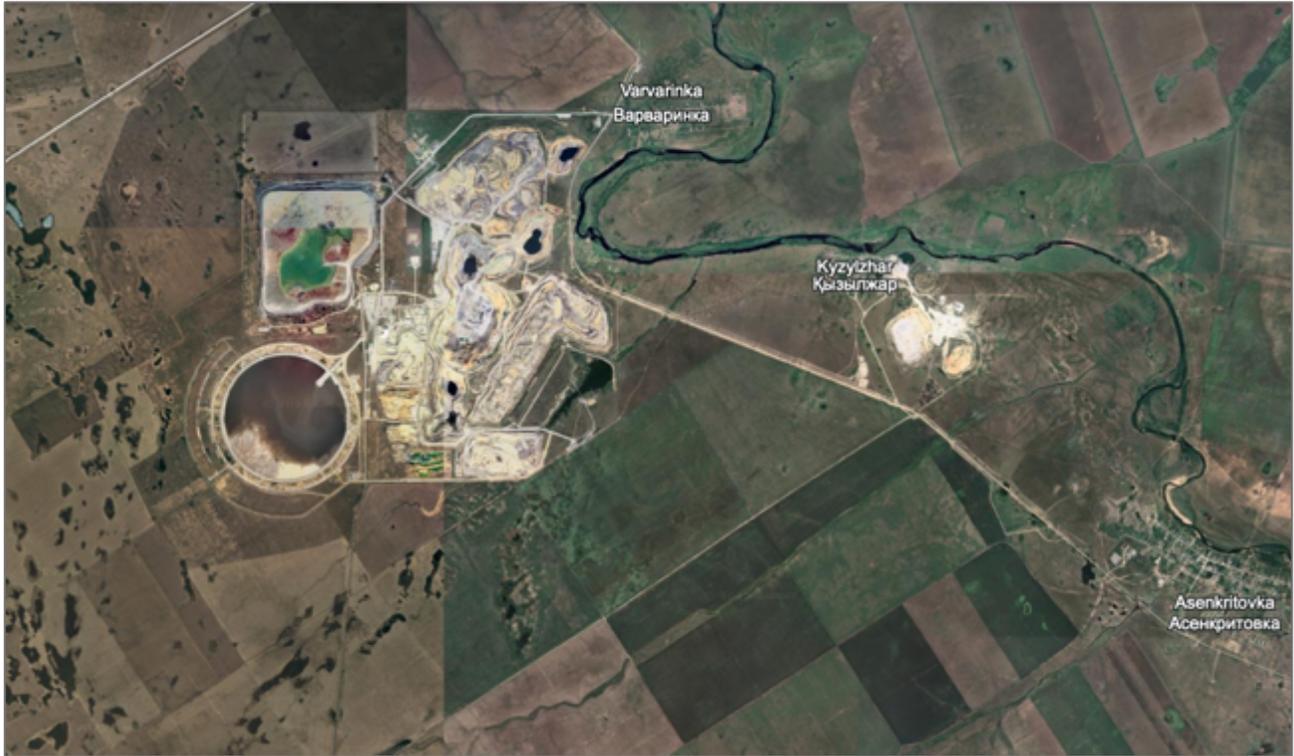
**Figure B: Varvarinskoye Operational Facilities in 2025, Including New TSF**

JSC Varvarinskoye (hereinafter referred to as “Varvara”) comprises of an open-pit gold mine and also mines ore from Komarovskoye (“Komar”), a high-grade gold deposit which Solidcore Resources acquired as part of the purchasing of Varvara from Polymetal. The feedstock from Komar (2 Mt/yr) is transported by rail to Varvara processing plant and blended with the ore from Varvara’s open pit. Since the previous audit, Varvara has built a new Tailings Storage Facility (“TSF”), birds eye view of the operational facilities including the new TSF can be seen on Figure B below.

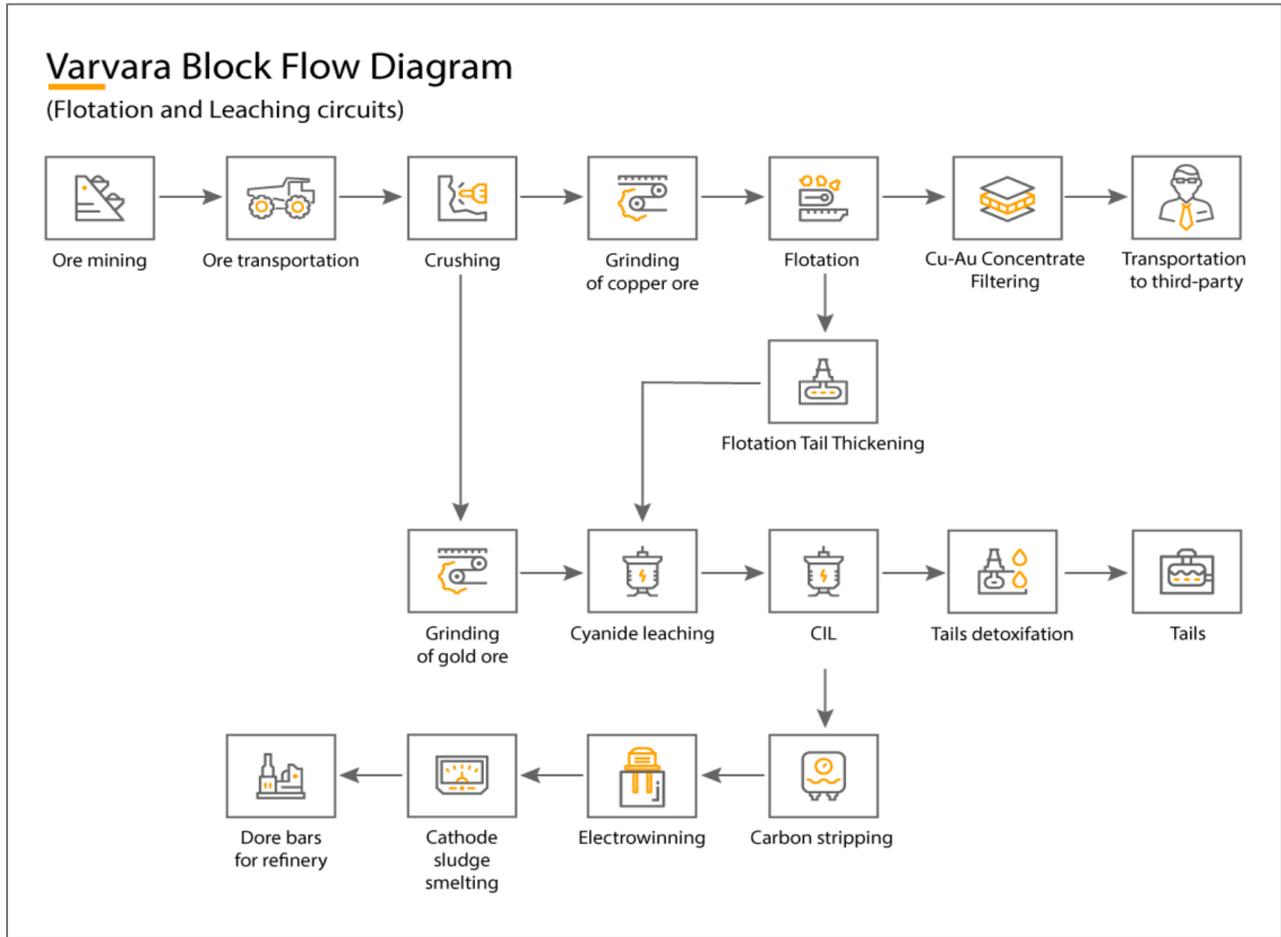
**Figure C: Varvara Process Flow Diagram**

The ore has a relatively simple process, the block flow diagram of the gold circuit at Varvara using a cyanidation process is shown on Figure C below.

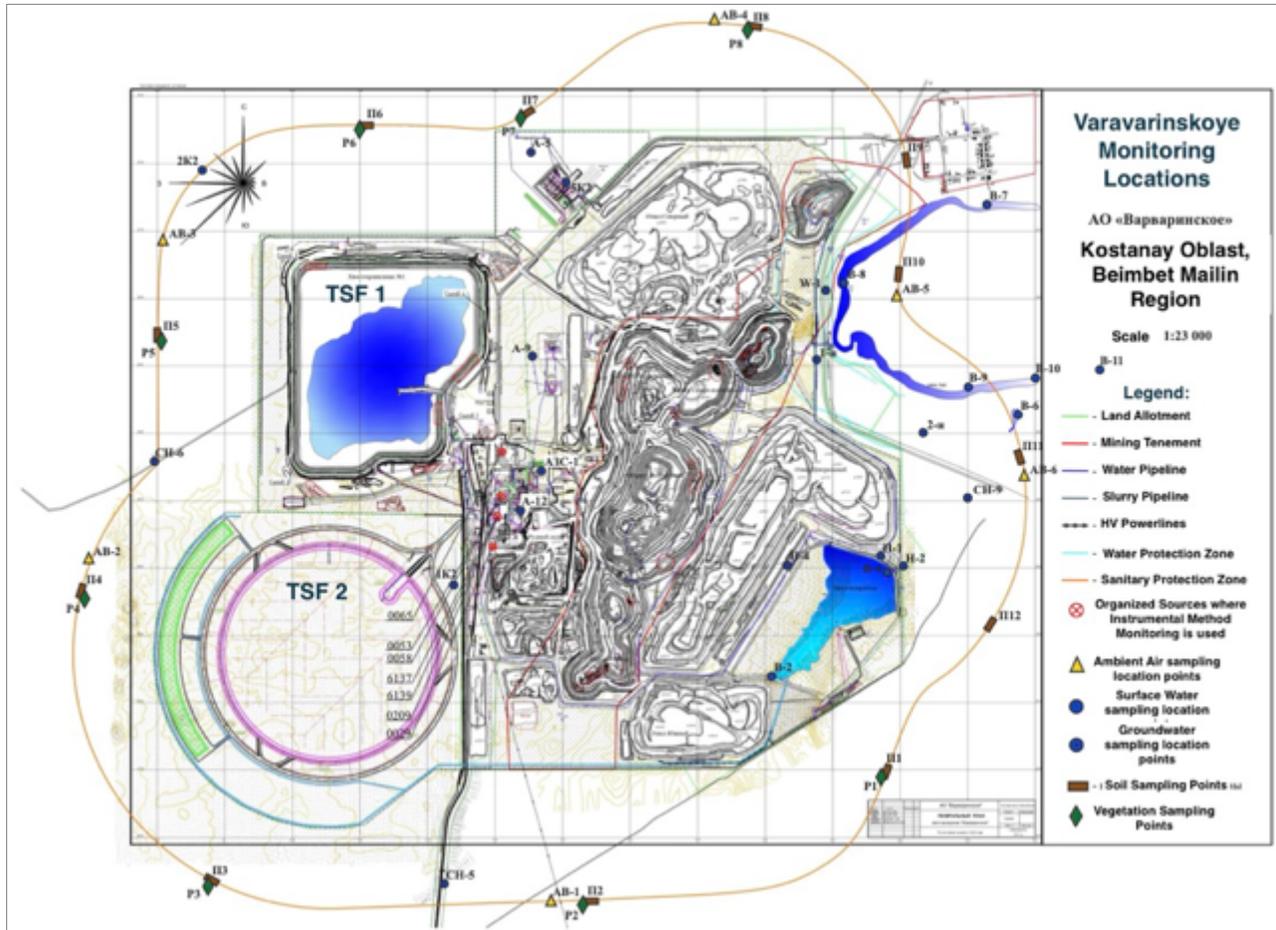
**Figure D: Varvarinskoye JSC Monitoring Locations**

Varvara has developed procedures and monitoring activities for boreholes and sampling. The monitoring program showing sampling locations and protocols has been provided to the auditors and seems adequate. Monitoring locations for air, water, soil and biota can be seen on Figure D.

Sampling is conducted apropos the monitoring program and seems sufficient. Groundwater sampling is upstream and downstream of cyanide facilities. As part of the monitoring activities, recording/photographing of wildlife is undertaken. Disturbance to wildlife is minimised during sampling procedures.
