Gold Mining Operations

Summary Audit Report

Anglo Gold Ashanti Ltd/

Queiróz Facility.

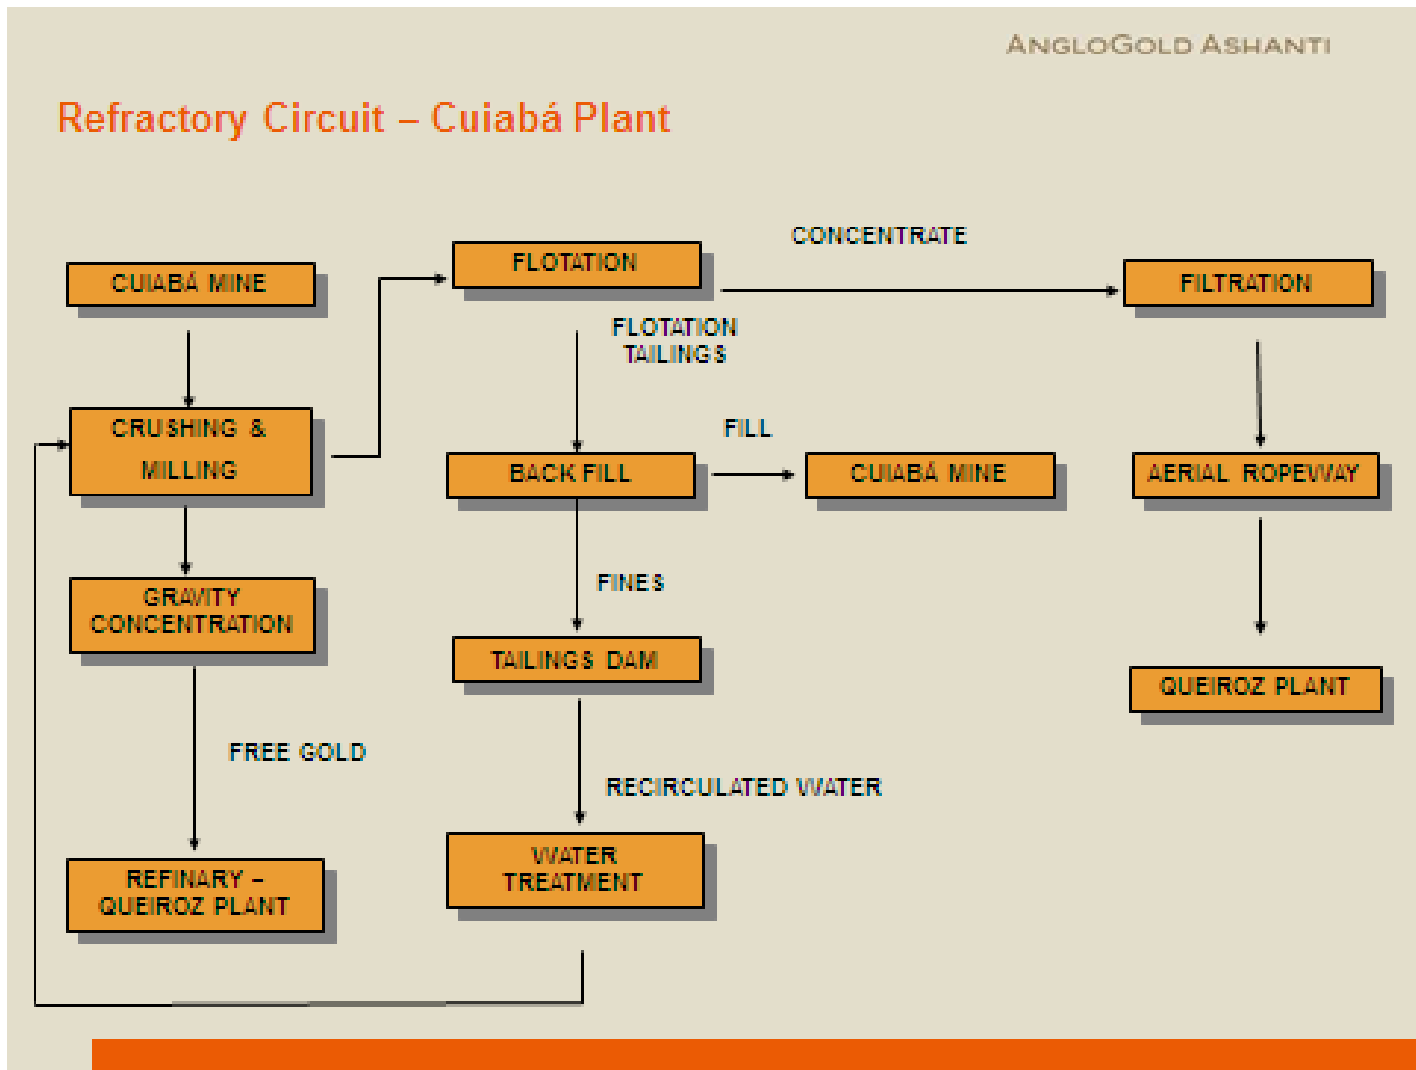
4. **Cuiabá Plant Process (not included in the cyanidation process/ (this means that the Cuiabá Plant IS NOT A CYANIDE FACILITY)):**

Gold ore production process starts at Cuiabá mine/ plant where the mechanical treatment is situated. After that, the concentrate containing gold goes to Queiróz Plant where the Pyrometallurgy, Hydrometallurgy and Foundry processes are responsible to obtain the final product. A description of each process step is given below:
