POLYMETAL VARVARINSKOYE MINE, KAZAKHSTAN MINING OPERATIONAL SUMMARY AUDIT REPORT

OCTOBER 2022

WARDELL ARMSTRONG INTERNATIONAL

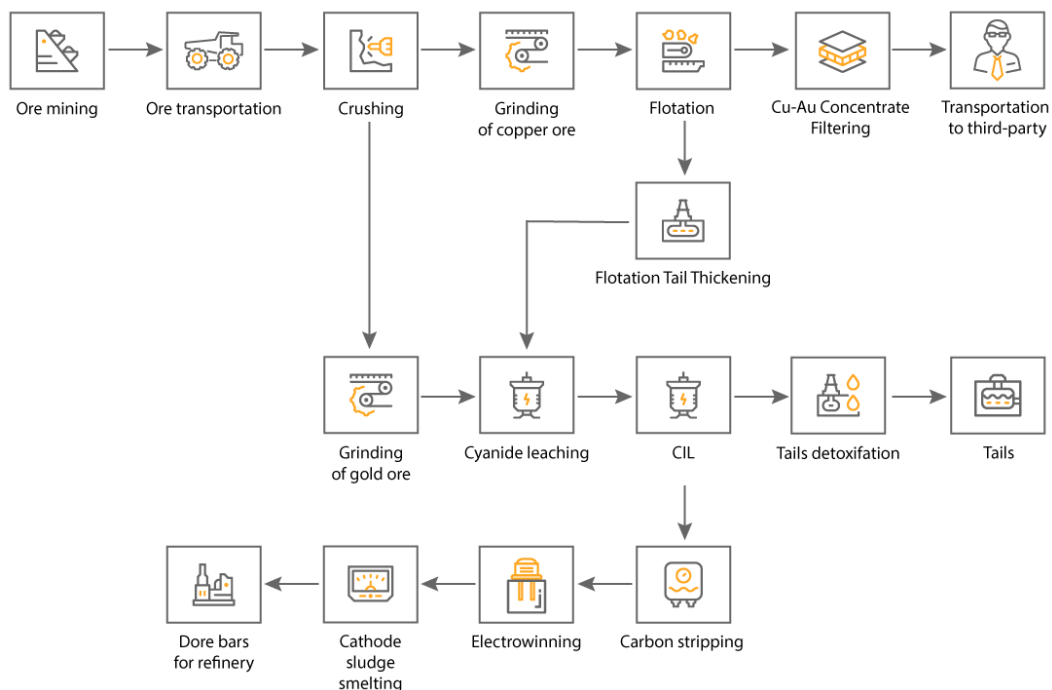
Figure 3: Block flow diagram of Varvara processing hub

The feedstock for Varvara processing hub is from Komar and Vavara open pits. The ore processing is relatively simple, see figure 3 below, the block flow diagram of the gold processing circuit. The process uses cyanide to recover the gold from the ore rock. Cyanide is sourced to site through an accredited supply chain (see further details below). Varvara uses fresh water for cyanide mixing from the river Ayat and also water from the precipitation pond and the open pit. Tailings water is recovered and used in the process plant (milling), this is detoxified water (treatment prior to discharge to TSF) the water is regularly tested and is less than 0.5 mg/L Weak Acid Dissociable (WAD) cyanide. The water is again tested before feeding back into the plant to confirm it is less than 0.5 mg/L WAD cyanide.

Varvara Block Flow Diagram

(Flotation and Leaching circuits)
