NEWMONT CERRO NEGRO

MINING OPERATION SUMMARY AUDIT REPORT

FOR THE
INTERNATIONAL CYANIDE MANAGEMENT CODE

SEPTEMBER 2022

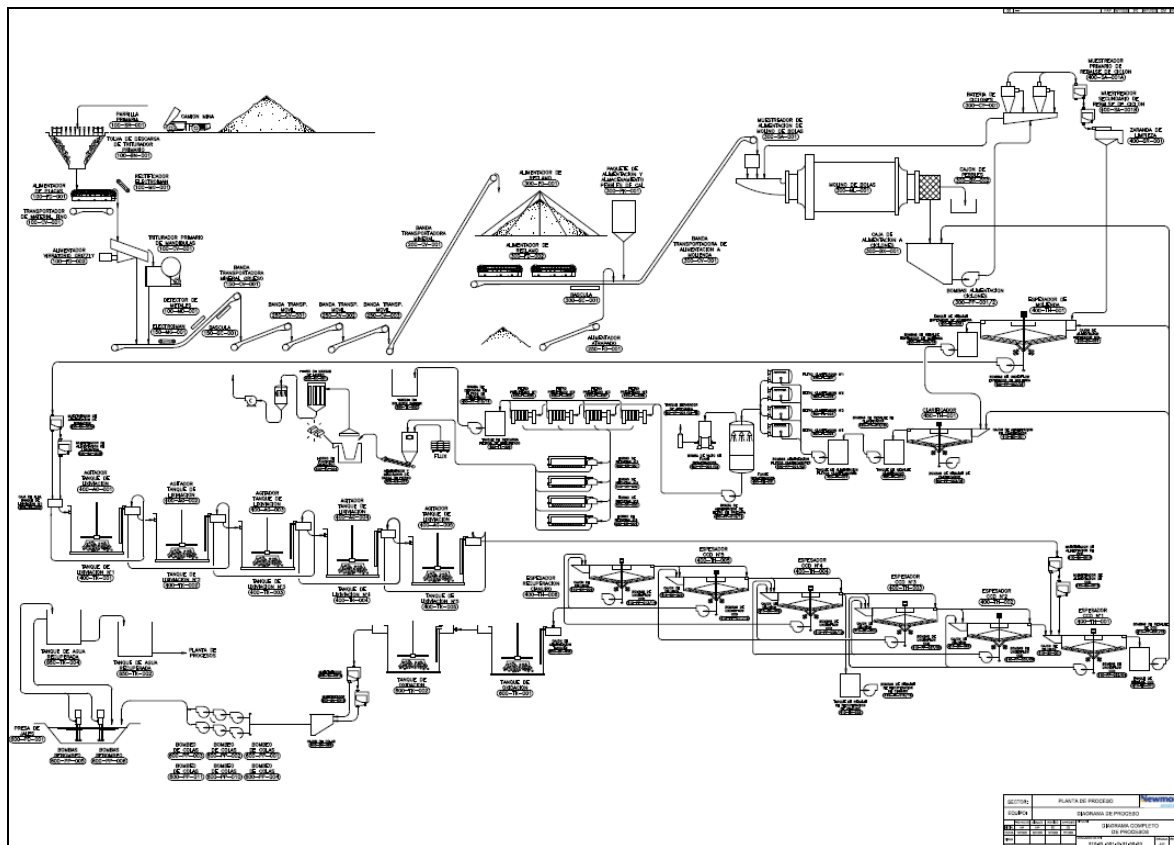
The Cerro Negro process plant is displayed in a schematic below. The operations in this schematic were reviewed during the certification auditing process.
